TECHNICAL BULLETIN

SUBJECT: Failures Associated with HRSG Bypass Desuperheaters

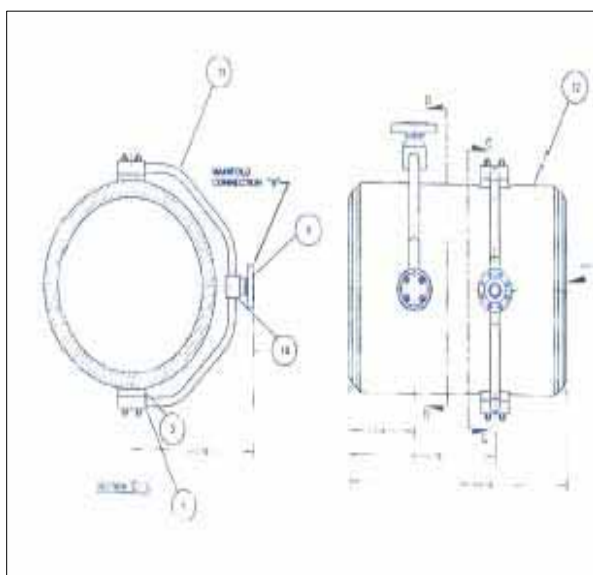
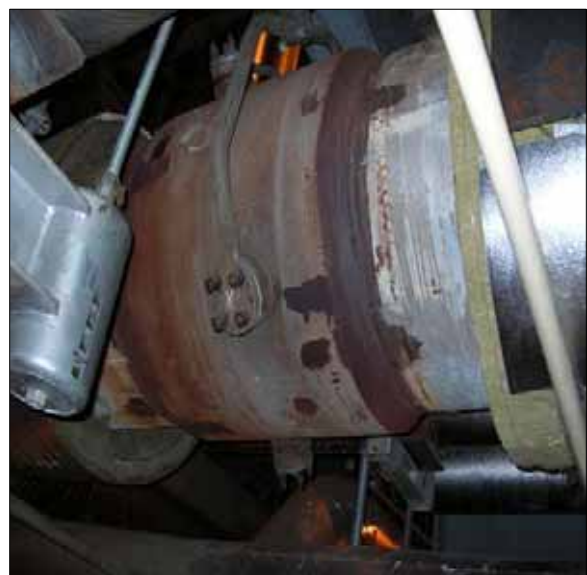
Fig. 1.

In particular, the design that has shown the greatest propensity for failure involves a heavy-walled desuperheater fitting with multiple spray nozzles around the circumference. The sketch and photograph provided in Fig 1 detail this arrangement. These failures are occurring on the downstream side of the Desuperheater at the circumferential weld joining the thin walled down-stream piping.

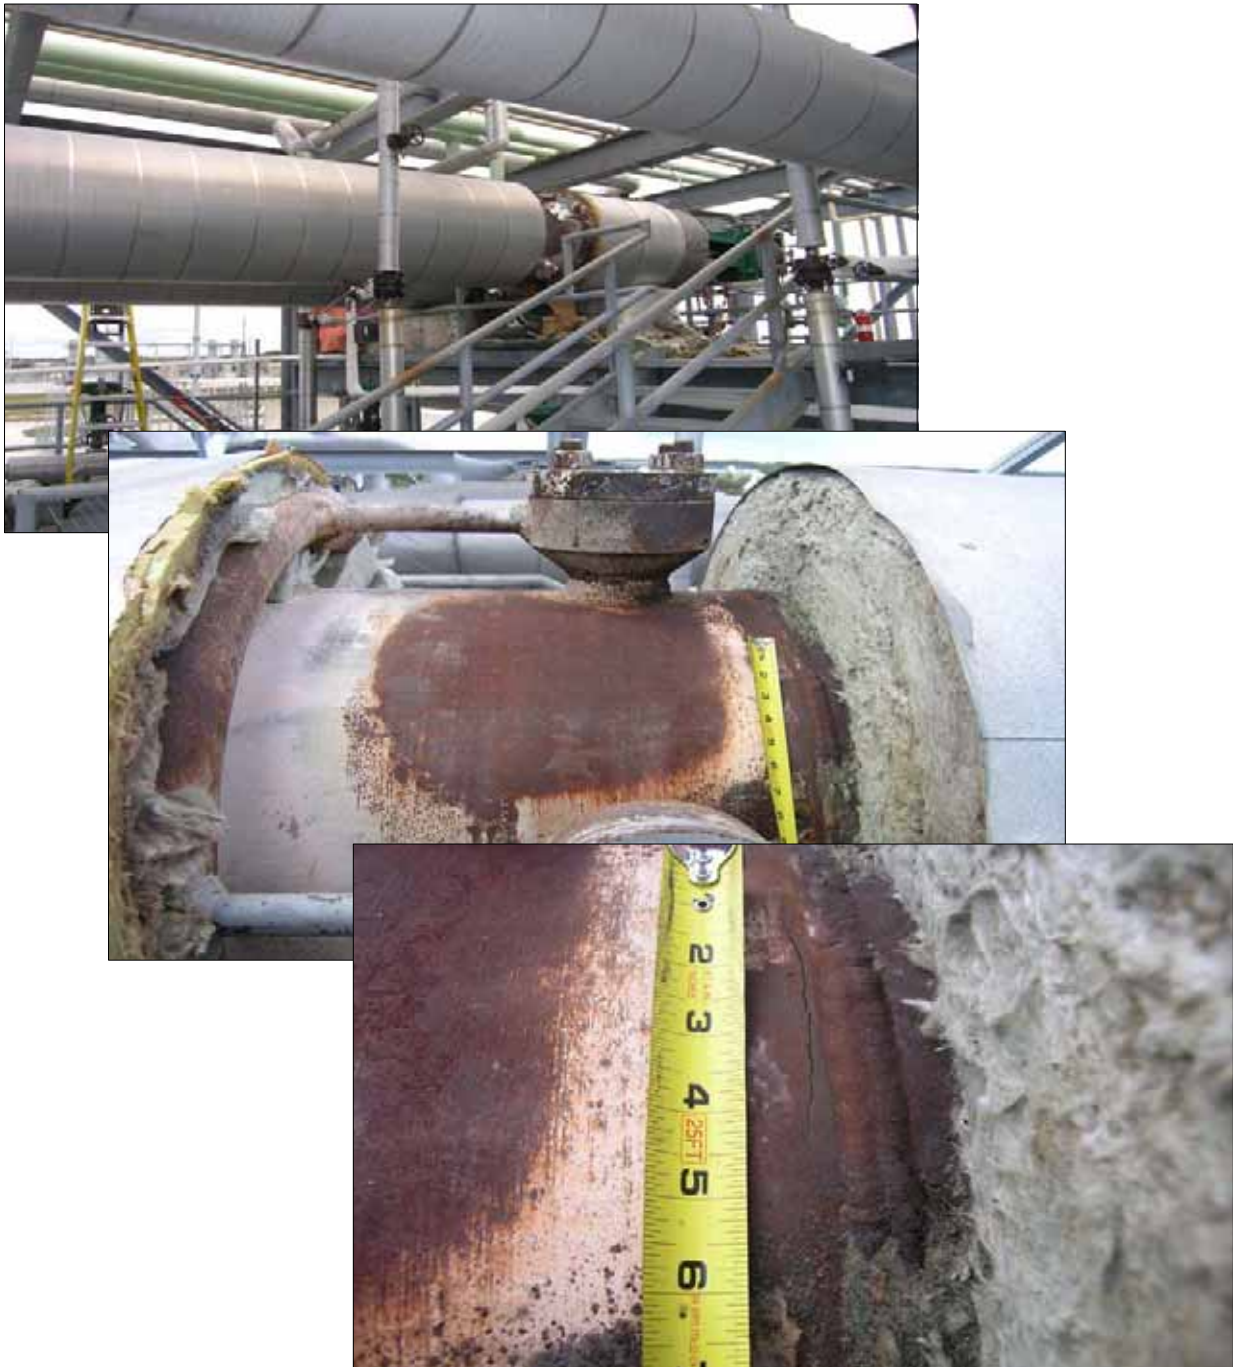
Views of inside diameter initiated cracking at the circumferential weld between the Desuperheater fitting and the bypass piping system is shown in the photographs provided in Fig. 2.

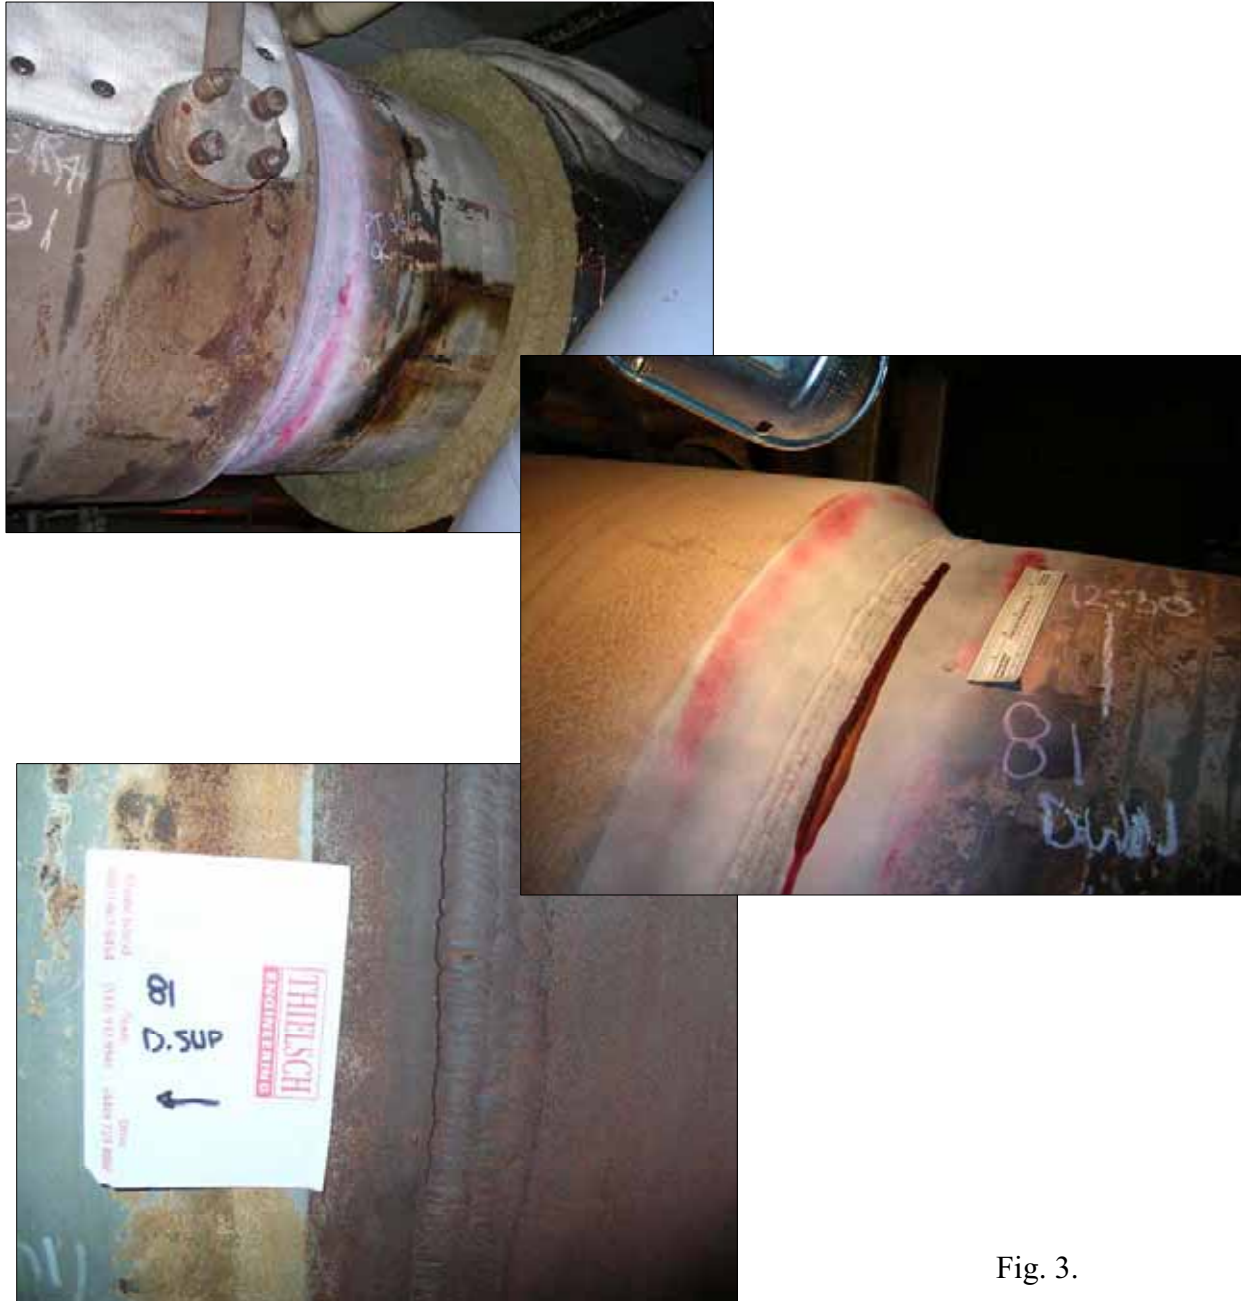
Fig. 3.

This next set of photographs details an instance where thermal gradients created during Desuperheater operation resulted in applied bending stress to the piping system. This caused the cracking to initiate on the outside diameter surface as shown in Fig 3.

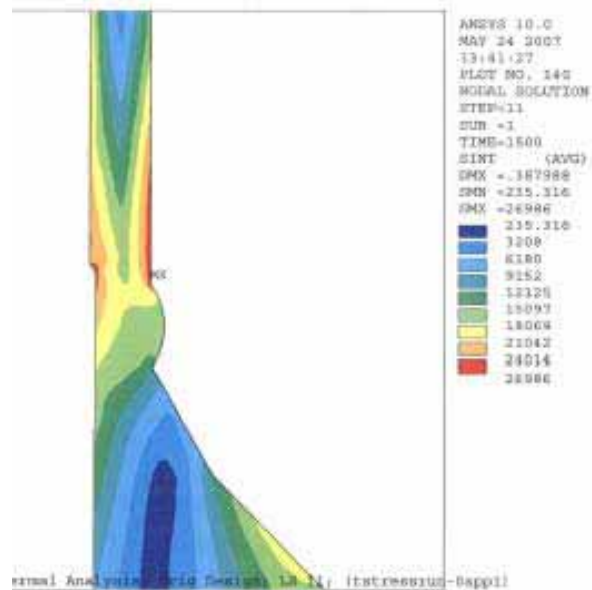
Fig. 4.

This specific case was modeled for a finite element analysis to demonstrate the magnitude of the thermally-induced bending stresses on the Desuperheater joint. The magnitude of the loads show that crack initiation could occur in less than 100 cycles of operation as shown in Fig 4.

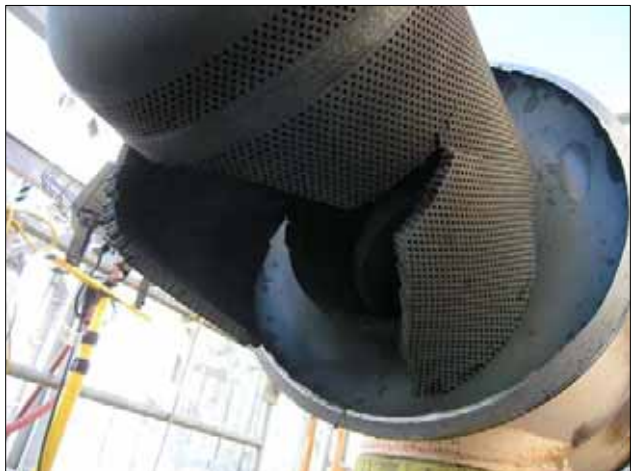
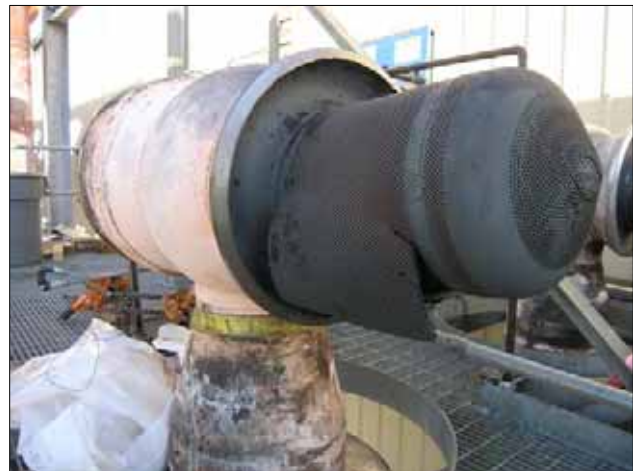
This last set of photographs shows a condition where the Desuperheater fitting has been removed and the damage to the internal diffuser can be seen. Again, this condition is related to thermal gradients from the relatively cold spray water thermally shocking the hot internal components.
