Finding and fixing cracks in high-temperature headers

The welds on superheater and reheater headers are arguably the most stressed parts of a modern steam plant. For that reason, it's surprising that they also may be the most under-inspected. Cracks are rare, but they can be repaired if found early. One plant avoided a long forced outage to replace a reheater outlet header by using the correct condition assessments and welding techniques.

By Peter Kennefick, Thielsch Engineering Inc.

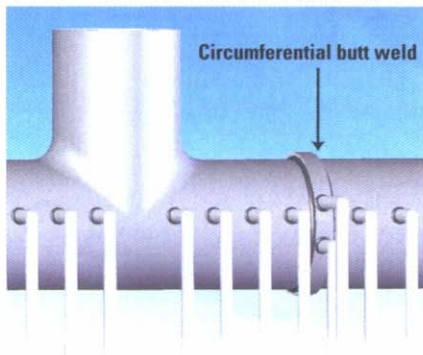
1. Ligament damage. Circumferential butt welds on high-temperature/pressure steam headers have proven susceptible to deterioration. They should be regularly inspected. *Courtesy: Thielsch Engineering Inc.*

a limited inspection. Restrict it to headers prone to service-related deterioration and to areas on them where a row of tube holes substantially overlaps or bisects a circumferential butt weld (Figure 1). Recent reports from the field indicate that these areas may be susceptible to severe ligament cracking. The level of susceptibility has three factors: the designs of the header and the weld, the composition of the weld's final filler material, and the stresses associated with normal operation.

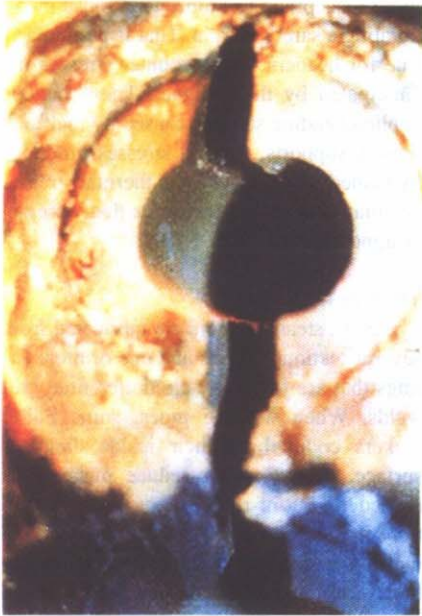
2. Crack attack. A circumferential crack that spanned the thickness of a high-temperature header. *Courtesy: Thielsch Engineering Inc.*

Two case studies provide anecdotal evidence that the cracking is attributable to poor welding practice. In one case, a visual inspection of a header at a Midwest utility steam plant revealed ligament cracking in multiple tube rows (Figure 2). The most severe cracks were in tube holes that overlapped circumferential girth welds—which a borescopic inspection (Figure 3) revealed were counterbored and flat-topped during the unit’s fabrication. A subsequent metallurgical evaluation confirmed that the girth welds, which had been completed using low-carbon filler material, were vulnerable to advanced creep deterioration. Surprisingly, the header base material itself showed no evidence of creep deterioration.

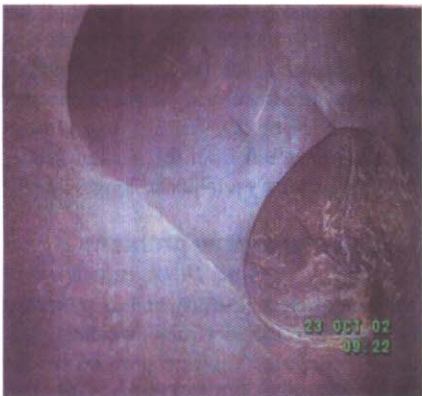
3. Trust your eyes. An example of the significant cracking along the inside diameter of the header, as revealed by a borescopic inspection. *Courtesy: Thielsch Engineering Inc.*

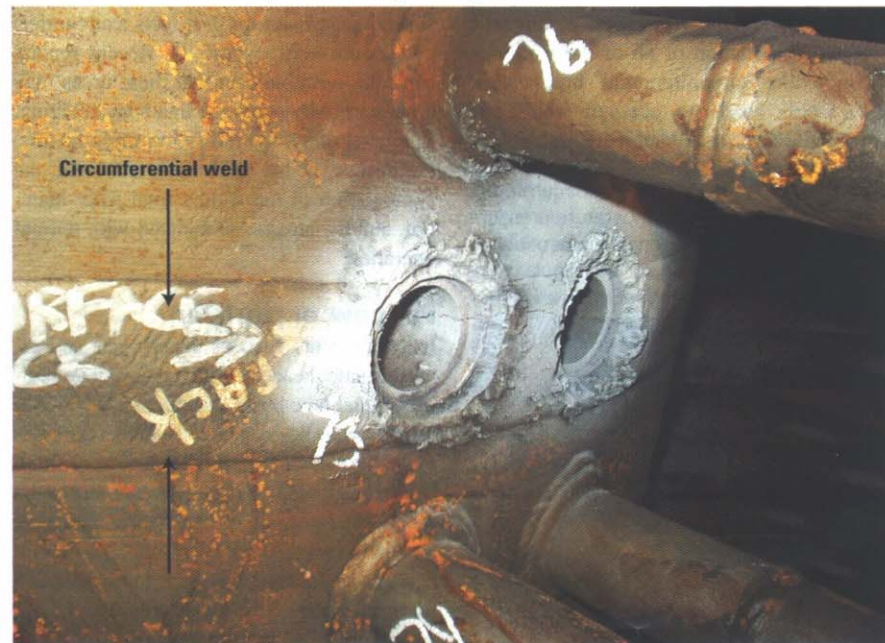
In the second case, a high-temperature header in a steam generator powering a plant in the Southeast began leaking after 28 years of service (Figure 4). Again, a visual inspection confirmed that, in the area where the leak occurred, the tube holes substantially overlapped a circumferential girth weld that was counterbored and used a low-carbon filler material. A borescopic inspection revealed ligament cracking across the cross-section of the header, which metallurgical testing confirmed was prone to cracking at points where it was welded to boiler

4. Bored to death. Bore holes after removal of tube stubs. Note the location of the circumferential weld. *Courtesy: Thielsch Engineering Inc.*

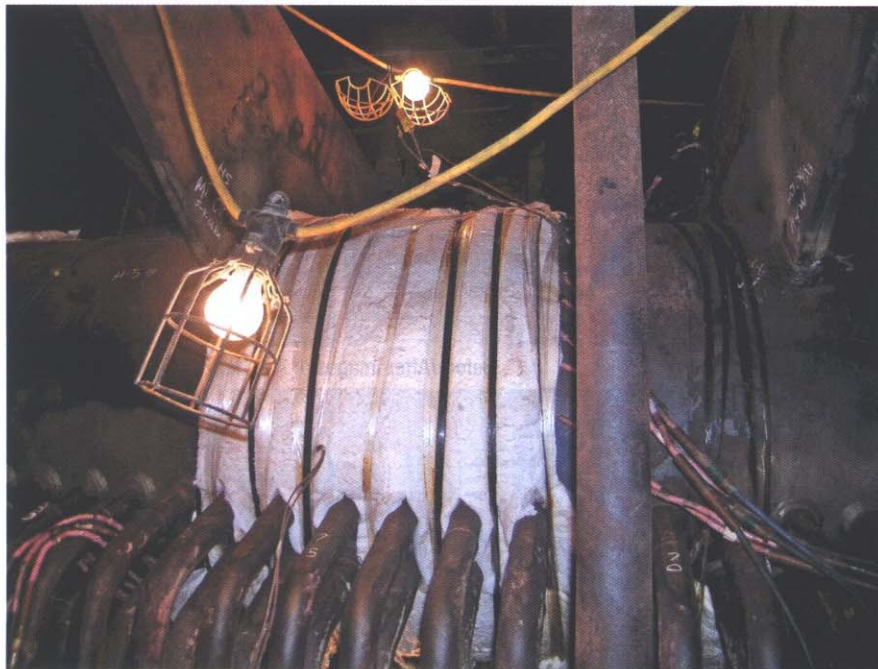
5. Hot to trot. The joint was preheated to 550F to begin the weld repair. *Courtesy: Thielsch Engineering Inc.*

temperature was then raised 200 degrees F per hour to a temperature of 550F (Figure 5) before the ligament could be welded. Prior to welding, each area was carefully checked with Tempilstiks to ensure that the minimum preheat temperature had been achieved. The preheat temperature was monitored by thermocouples and Tempilstiks throughout the entire repair process. Finally, the area was heat-soaked at 500F for a minimum of three hours.

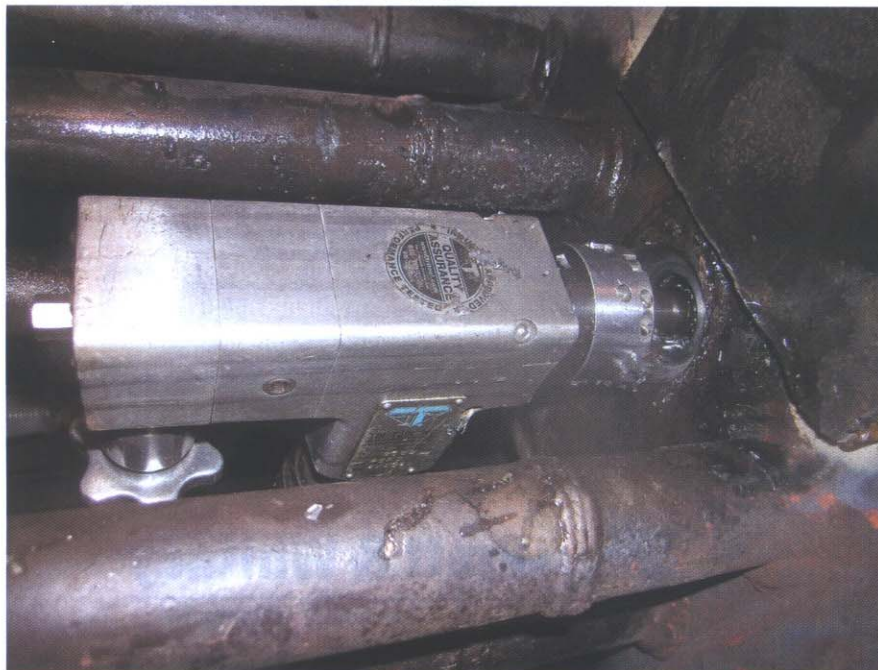
6. Precision bore. Two tube bores were precision-machined for the new tube-to-header connections. *Courtesy: Thielsch Engineering Inc.*

A 1/8-inch reinforcement cap was applied over the section of the header surrounding the two tube bore openings that were weld-repaired. The two tube bores then were machined in place, and new tube stub-to-header sockets were machined (Figure 6) to facilitate reinstallation of the tube stubs. Figure 7 is a sketch of the machined joints. Care was taken to properly align the new bore openings with the remaining tube stubs.

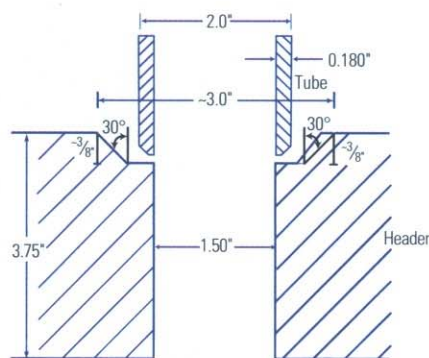
7. Plan ahead. A sketch of the tube-to-header joint used in a high-temperature header weld repair. *Source: Thielsch Engineering Inc.*
