# THIELSCH ENGINEERING, INC.

## THE VALUE OF PMI TESTING

### JUST BECAUSE IT'S SPECIFIED DOESN'T MEAN IT'S TESTIFIED

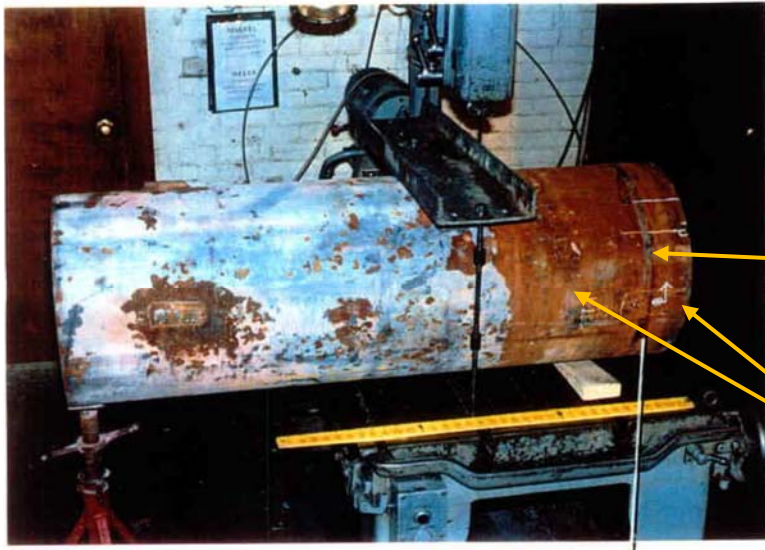
Along with other laboratory tests, a chemical analysis was performed using Optical Emission Spectroscopy (OES) of a pipe section and the weld metal. The results of the analyses showed the pipe material conformed to ASTM Specification A335, Grade P11 alloy steel. However, the weld metal chemistry is typical for AWS SFA-5.1 E-6010 or E-7018 mild steel electrode, or carbon

steel. Fig. 1 shows an overall image of the pipe segment illustrating the cracking location. Fig. 2 shows a close up of the cracking condition. Fig. 3 shows a laboratory sub-segment of a cross-section of the crack.

Overall image of the pipe segment illustrating the cracking location.

Cracking occurred in the girth weld of the pipe sample from the Main Steam piping system due to severe creep deformation. The premature creep of this weld metal was due to improper use of low carbon steel electrodes in a weld joining 1-1/4 Cr - 1/2 Mo low-alloy steel piping. It is important to acknowledge, that while the weld material was of a significantly inferior material for high-temperature service, it still operated for nearly 28 years without incident.

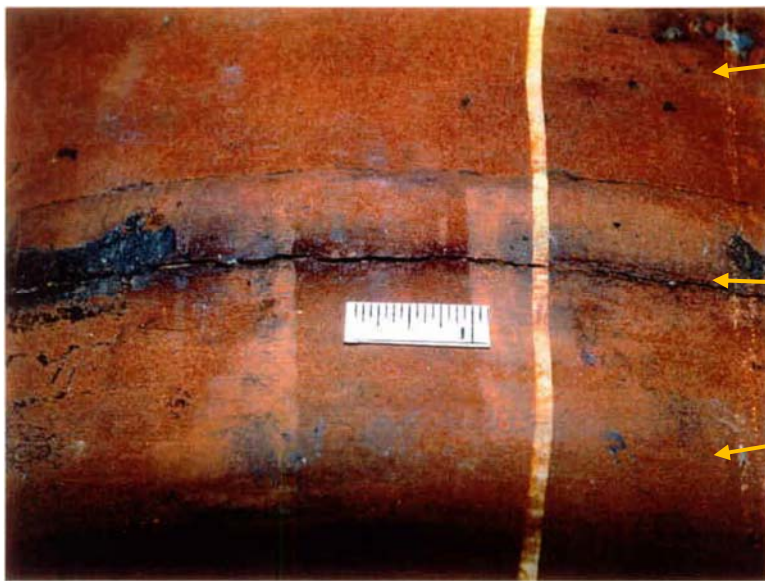
Fig. 2

Close up of the cracking condition.

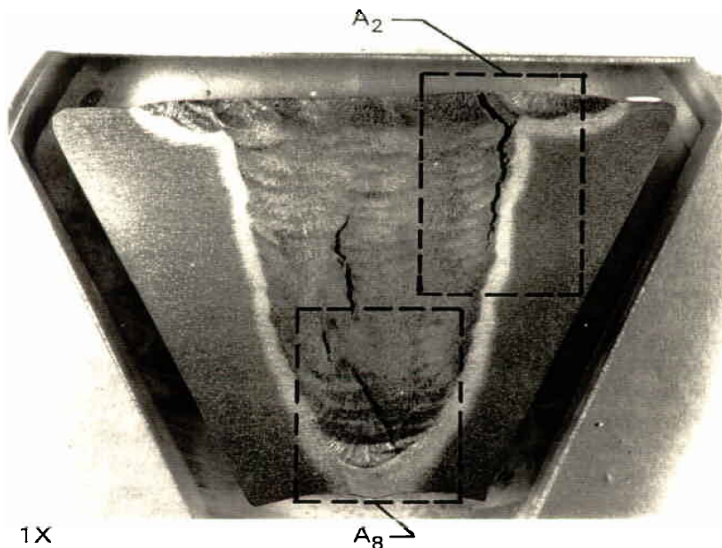
Fig. 3

Laboratory sub-segment of a cross-section of the crack.

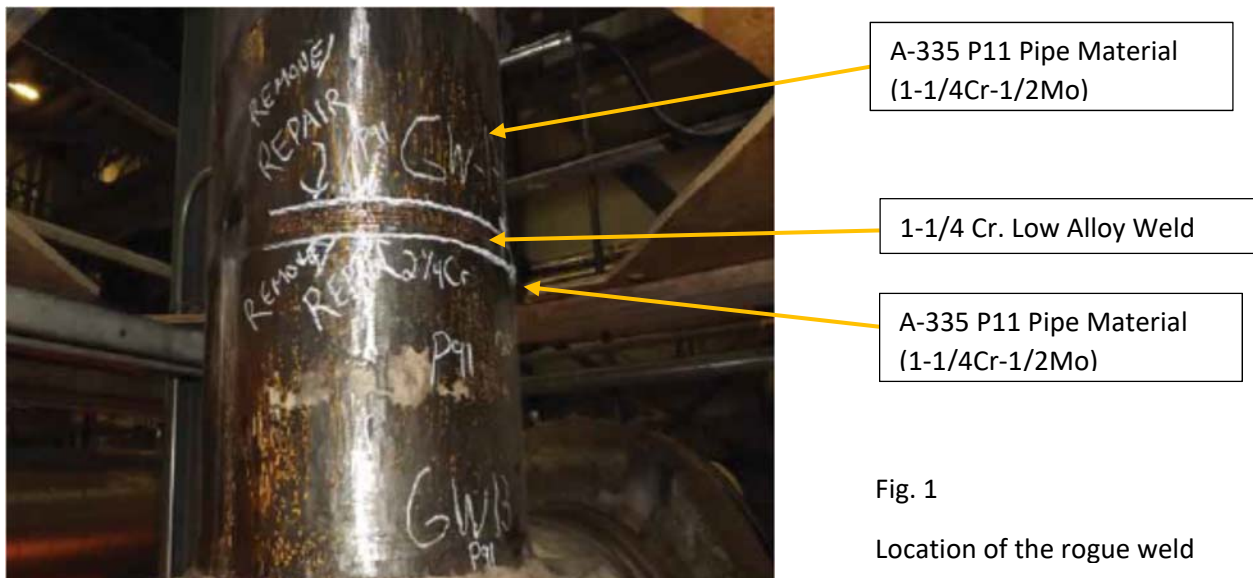
In addition to other routine metallurgical examinations, a positive material identification (PMI) was performed on the accessible welds and base material sections of the Hot Reheat piping system using x-ray fluorescent spectroscopy. The PMI examination of the Hot Reheat piping system revealed that the vast majority of the locations tested were manufactured and fabricated with the specified modified 9 Cr creep resistant ferrite steel. However, at one particular girth weld, the weld material was consistent with 2-1/4 Cr low alloy material. It was recommended to remove and replace the 2-1/4 Cr material weld metal with the proper higher grade 9 Cr filler material. While no significant service related deterioration was revealed in this rogue weld location during the examination, it would have a significantly reduced life expectancy than the higher creep resistant modified 9 Cr material. Fig. 1 and 2 show the location of the rogue weld. Fig. 3 shows the PMI results of the evaluation at this location.

Location of the rogue weld

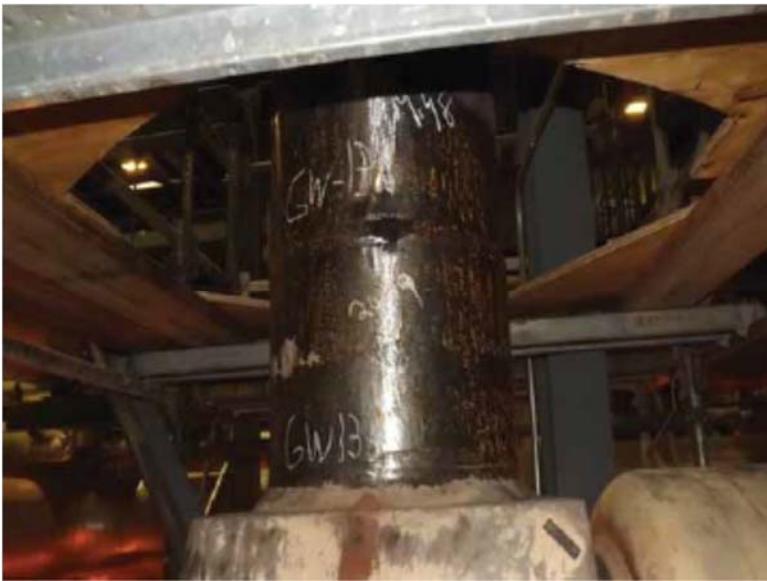
Fig. 2

Location of the rogue weld

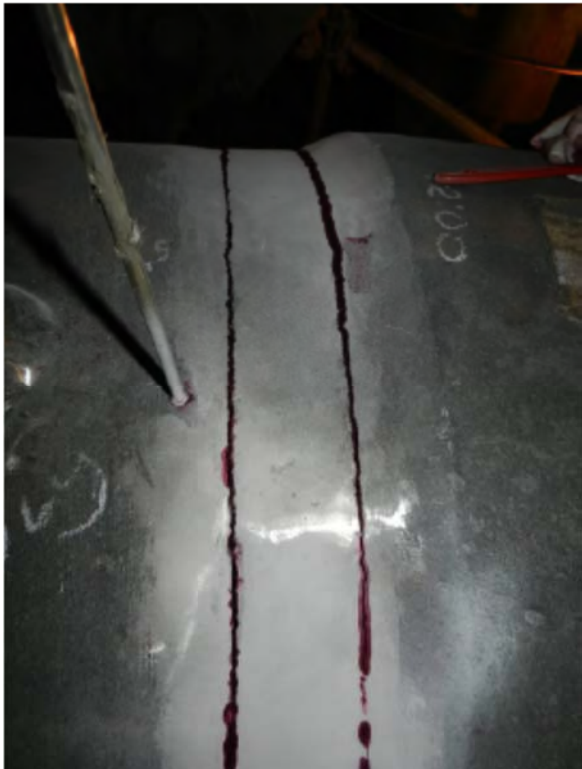
Fig. 1

Utilizing visual, magnetic particle and ultrasonic phased array examinations, an extensive 360-degree surface cracking was identified at several of the welds involved in the scope of work.

Due to the extent and nature of the cracking revealed, further evaluation of all welds and base material sections of the Main Steam piping system by positive material identification (PMI) was performed. The PMI examination of the Main Steam piping revealed that 7 of the 62 girth welds included in the scope of inspection were fabricated from carbon steel weld material. This carbon steel weld material is unsuitable for operation at 1015°F, as it does not possess the required creep-resistant properties. As such, the majority of these welds exhibit significant creep and fatigue deterioration.

Cracking conditions of one of the rogue welds from the Main steam piping system

All of the rogue welds were removed and repaired during the outage. Again, it is interesting to note that while these carbon steel welds exhibited significant deterioration and damage, they operated for over 35 years at high temperature, high-pressure conditions.

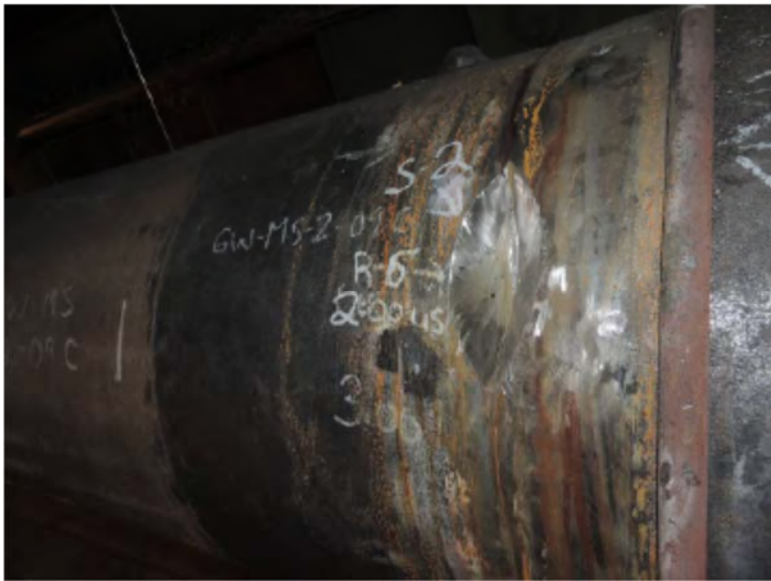
Fig. 2

Boat sample removal location

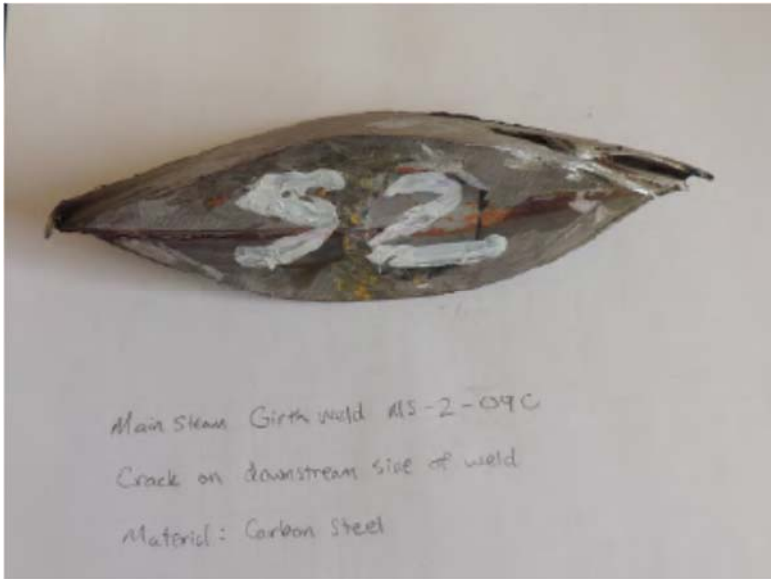
Fig. 3

Boat sample segment

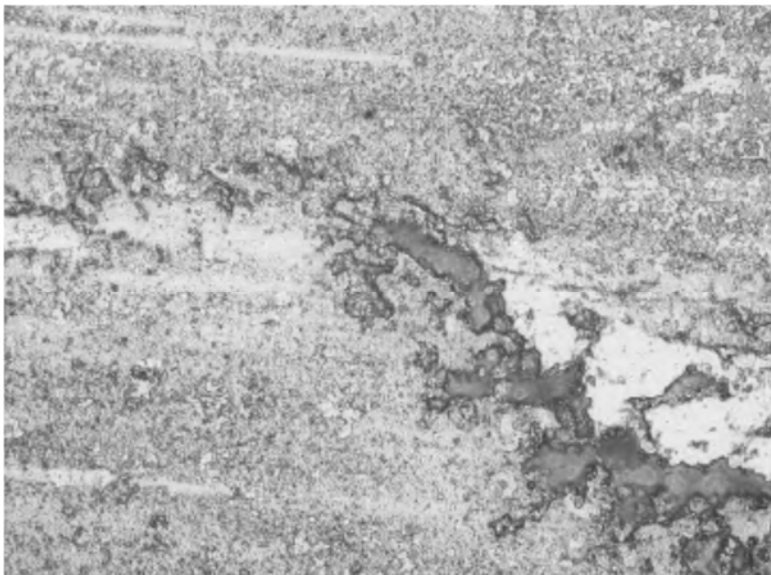
Fig. 4

Surface replication was performed at these rogue welds to determine the level of creep present. The microstructure of the welds observed in replicas consisted of ferrite and pearlite grains, and carbides, not consistent with the microstructure of 2-1/4 Cr - 1 Mo weld which normally consists of acicular bainite or bainite with limited amount of ferrite. Furthermore, the heat-affected zone of replicas revealed presence of fatigue cracking, creep voids, void linkage, and fissures. The atypical microstructure of the welds as well as presence of extensive cracking and creep damage in the heat-affected zones are attributable to the inferior carbon steel weld metal. Fig. 1 shows the cracking conditions of one of the rogue welds from the Main steam piping system. Fig 2 and 3 show the boat sample removal location and boat sample segment. Fig 4 and 5 show the typical replication from the rogue welds exhibiting advanced creep.

Typical replication from the  
rogue welds exhibiting  
advanced creep

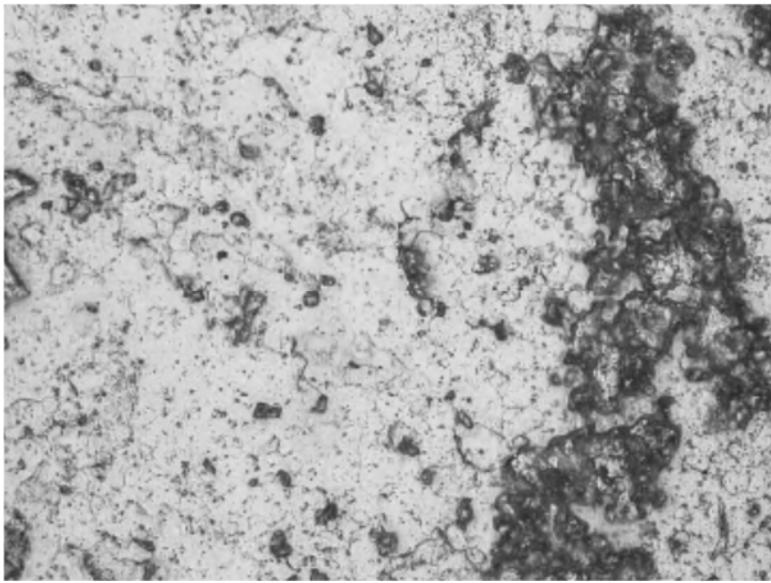
Fig. 5

Typical replication from the  
rogue welds exhibiting  
advanced creep
