# Forced Draft and Induced Draft Fan Examination

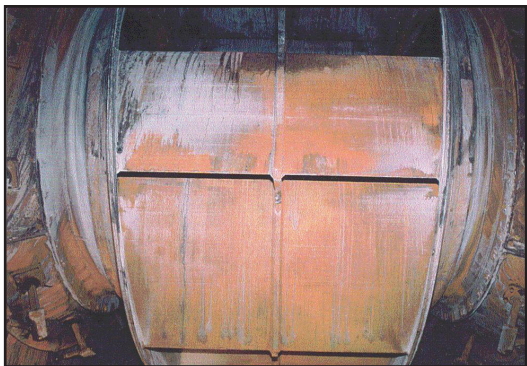
Fig. 1. Overall view of Induced Draft Fan.

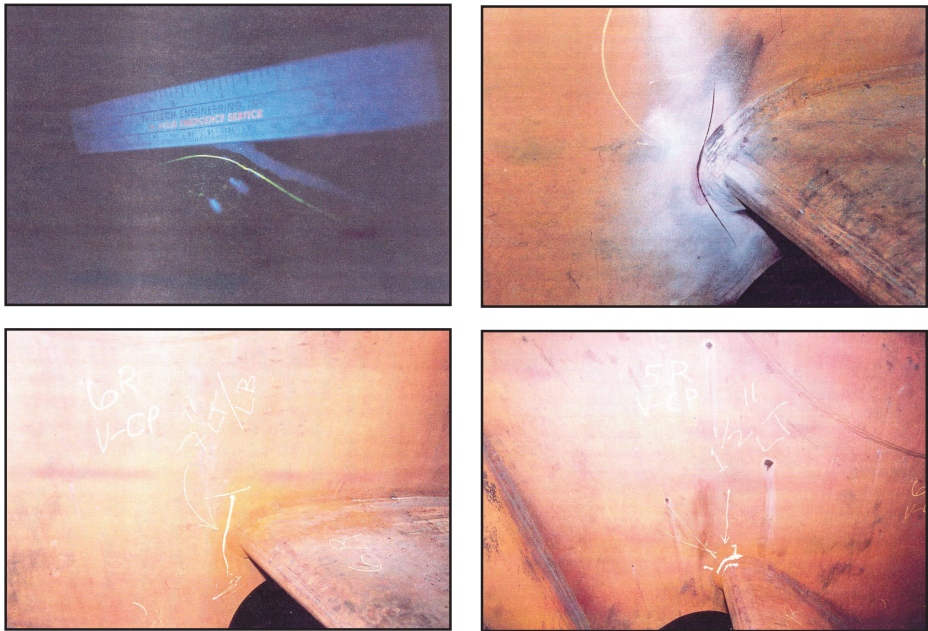
Our inspection program involves having the plant water wash the fan components prior to examination to remove heavy scale formation. Thielsch Engineering personnel will then prepare all welded joints by power hand grinding and wire brushing. This includes the outside shrouding, the center plate and both side of the air foil blading. Our qualified engineering and technical personnel will perform a detailed visual examination followed by a wet fluorescent magnetic particle examination. Indications of cracking are then evaluated to determine their cause and nature. Views of typical indications are shown in Fig. 2.

Fig. 2.  
Location and orientation of  
typical fan cracking.

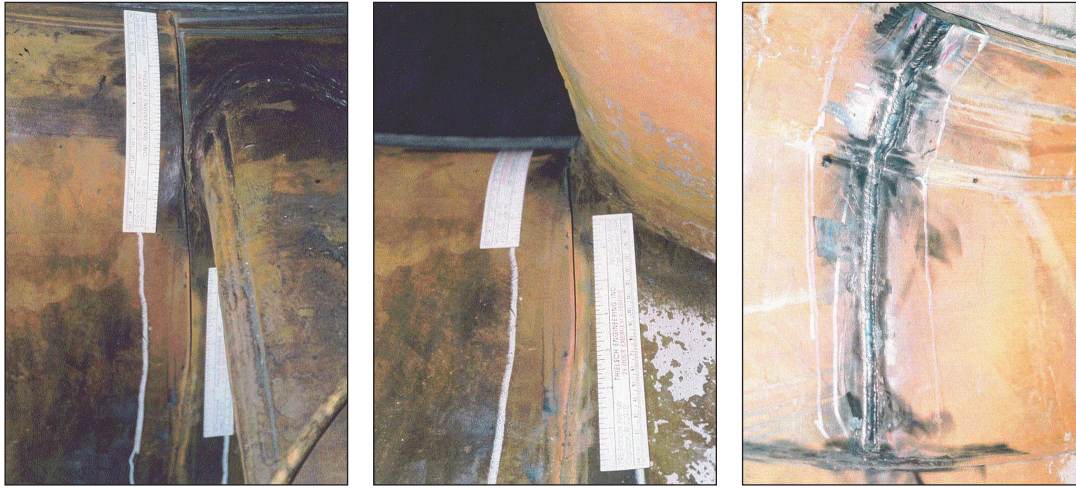
Fig. 3. Photographs of severe fan cracking and subsequent weld repair.

Based upon evaluation discovering any indications, Thielsch Engineering personnel can develop and implement proven low stress weld procedures for these high-strength, hardened materials. These procedures involve elevated preheat temperatures, specific weld bead placement and balanced welding techniques. Photographs of typical weld repairs are shown in Fig. 3.
