February 2010 Power Plant • Gas Line Explosion

Incident Management Services Case Histories

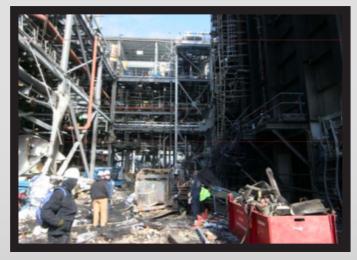
During a scheduled gas line blow procedure, a massive explosion occurred between the two newly constructed HRSG units. The blast wave lifted the HRSGs off their foundations severely distorting the primary frame columns and in some instances, shearing them completely.

Thielsch Engineering personnel were contracted by the EPC owner to perform the accident investigation and subsequently the damage assessment. Thielsch Engineering developed the blast wave map and heat profile map of the entire plant site. This was instrumental in determining which components and systems had been subjected to damage and which ones had not. This provided useful global evidence in convincing the components' OEM to maintain or to uphold their warranties on the equipment within this new plant.

Over the course of the twelve-month reconstruction, Thielsch Engineering provided engineered repair procedures to restore the damaged HRSG, the high-energy piping, and tank components; as well as project management of the repair process.

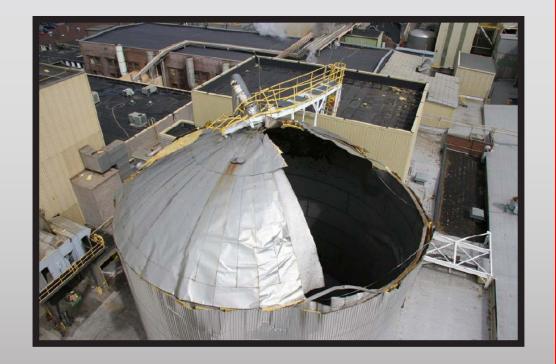
During a maintenance function atop a 75 ft. High-Density Stock Tank used in the manufacturing of recycled cardboard, an explosion occurred. This explosion tore off 25% of the domed roof, which resulted in three fatalities.

Thielsch Engineering personnel assisted the plant by providing initial accident investigation, drafting a safety plan for OSHA representatives, developing and supervising demolition, and collecting evidence.

Thielsch Engineering also conducted the accident reconstruction study, developed the design modification for the reconstructed tank, developed and evaluated the proposals for the selected construction firm and performed final field inspections.

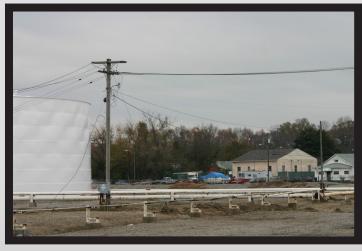
A 1.2 M Gallon Above Ground Storage Tank, used in the storage of liquid fertilizer, catastrophically collapsed in November of 2008.

This resulted in a tidal wave of fertilizer product 10-feet. high that breached the surrounding earthen berm and entered a residential neighborhood as well as the Chesapeake Bay.

Thielsch Engineering was retained to conduct the failure analysis of the tank shell as well as develop and implement an inspection protocol for adjacent Above Ground Storage Tanks. The metallurgical failure analysis conducted in our laboratory determined that a recent design modification to the tank attributed to the failure.

Thielsch Engineering subsequently re-engineered the safe fill heights for the remaining modified tanks and received approvals from the local authorities for continued operations.

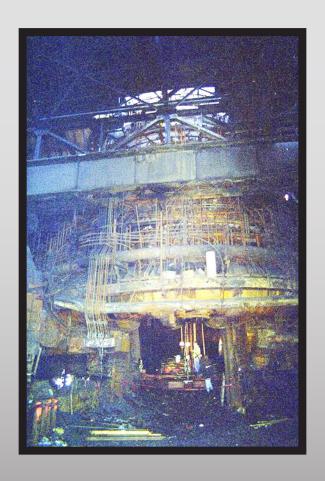
A Blast Furnace in the Midwest experienced two incidents that damaged the unit. The first incident occurred in the summer of 2003 and involved an explosion and fire in the Blast Furnace. Thielsch Engineering was contracted to determine the cause of this explosion. Our team of experts conducted in-depth site investigations and damage assessment of the Blast Furnace and Off-Gas piping systems, which were both subjected to the explosion and fire. This investigation included metallurgical analysis and a thorough review of the events leading to the explosion.

The second incident occurred in the winter of 2003 due to a loss of cooling water to several circuits. Minor repairs were made and the unit was placed back in service in an effort to meet production schedules. Both incidents severely damaged the furnace and its auxiliary equipment.

Thielsch Engineering was also contracted by the client to participate in the inspection program with the OEM, to develop a scope of work and establish the estimated cost for the reconstruction of "in kind" Blast Furnace.
